# Spanish Maritime Safety Agency

## **POLLUTION DETECTION FINAL REPORT**

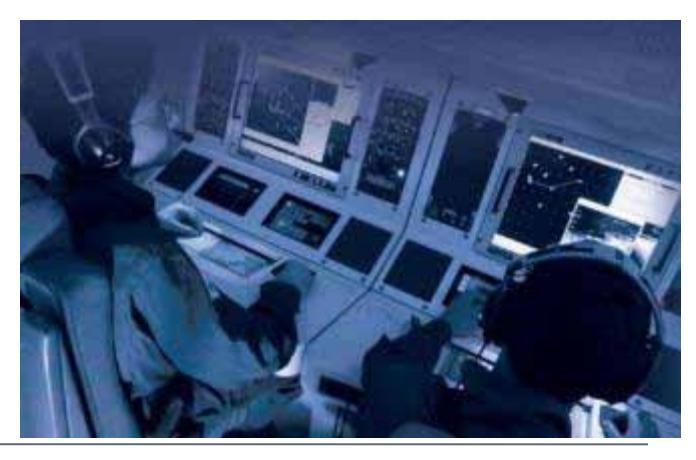
## Aircraft equipment

# 4 sensors for detection, classification and quantification of slicks on the surface of sea:

- SLAR, Side Looking Airborne Radar: for detection of long range, about 10 nautical miles both sides of aircraft, allows calculate the area of slick.
- **IR/UV, Infra red / ultraviolet:** Detection in short range (in the vertical plane) allows identify the spots where the pollution is thicker
- MRW, Microwave: To calculate volum of slicks.
- LFS, Laser Fluorsensor: Allows clasify the oil slick and determine thickness of thin films (0.1 to 20 micras)

- Camera high performance, gyroestabilized located outside of the aircraft that allows recordings of night and day images.
- High resolution photographic camera.
- AIS, Automatic Identification System of vessels.
- Radar for search.

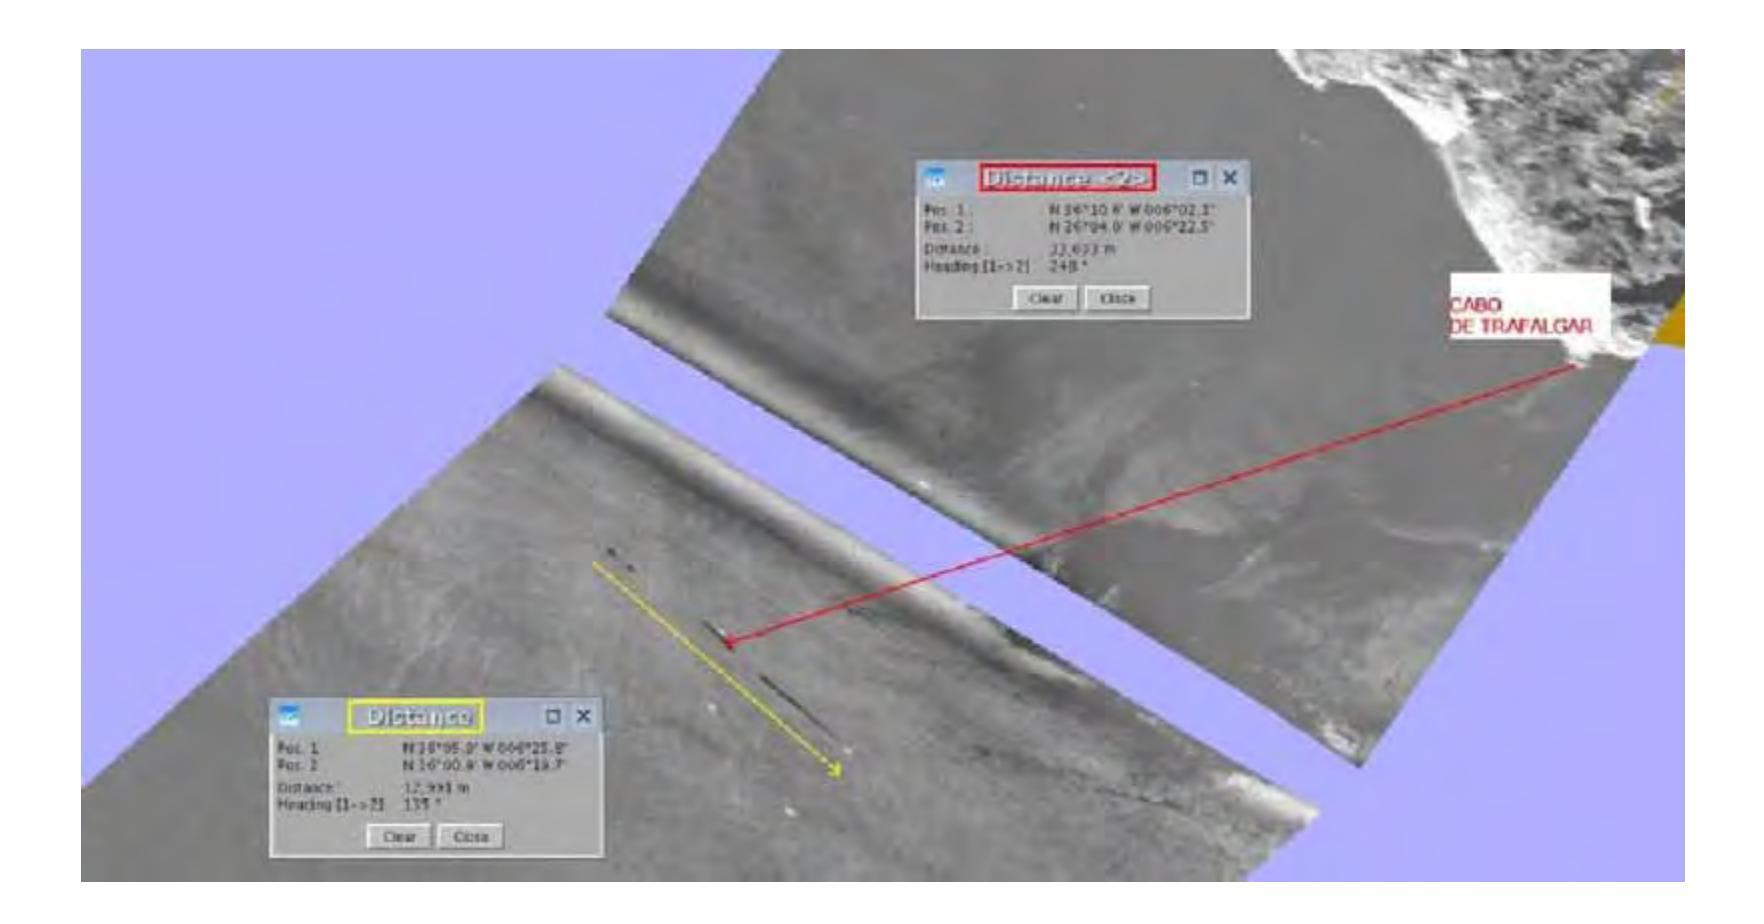
## **Slick position**

The slick position is bearing 248° from TRAFALGAR CAPE at 17,83 Nautical Miles, as shown in the following image.

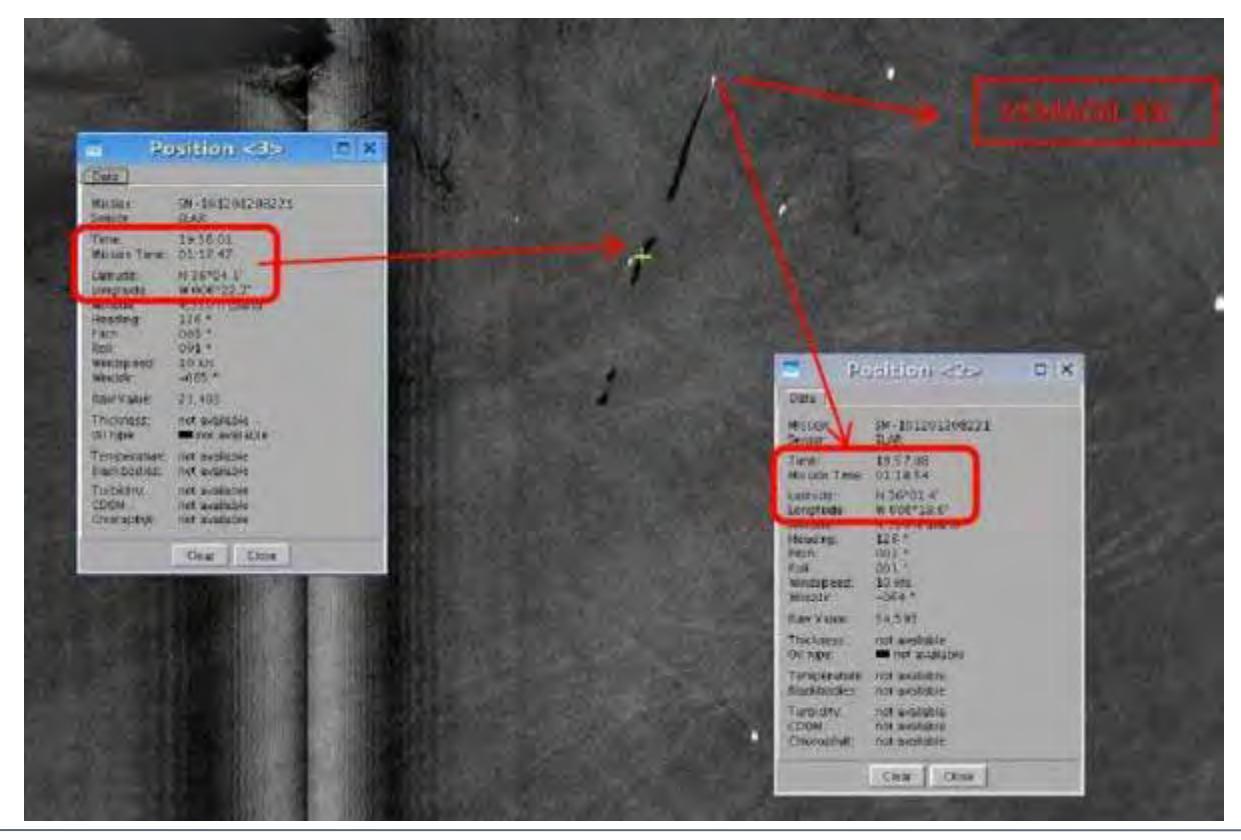
A. SENSOR SLAR

SLAR image showing:

the length and direction/area of the slick

the central point of the slick

the dimensions/shape of the plotted polygon.

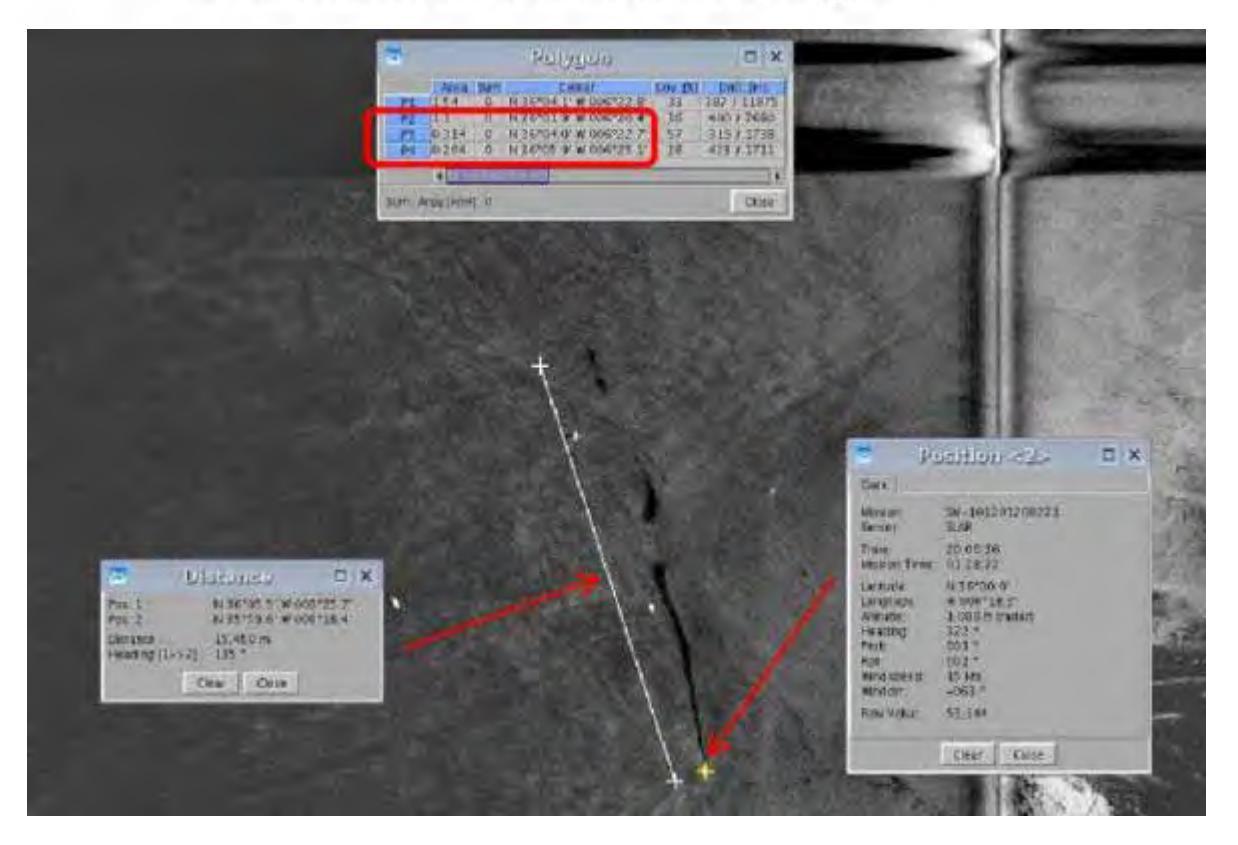
SLAR image showing:

the length and direction/area of the slick

the central point of the slick

the dimensions/shape of the plotted polygon.

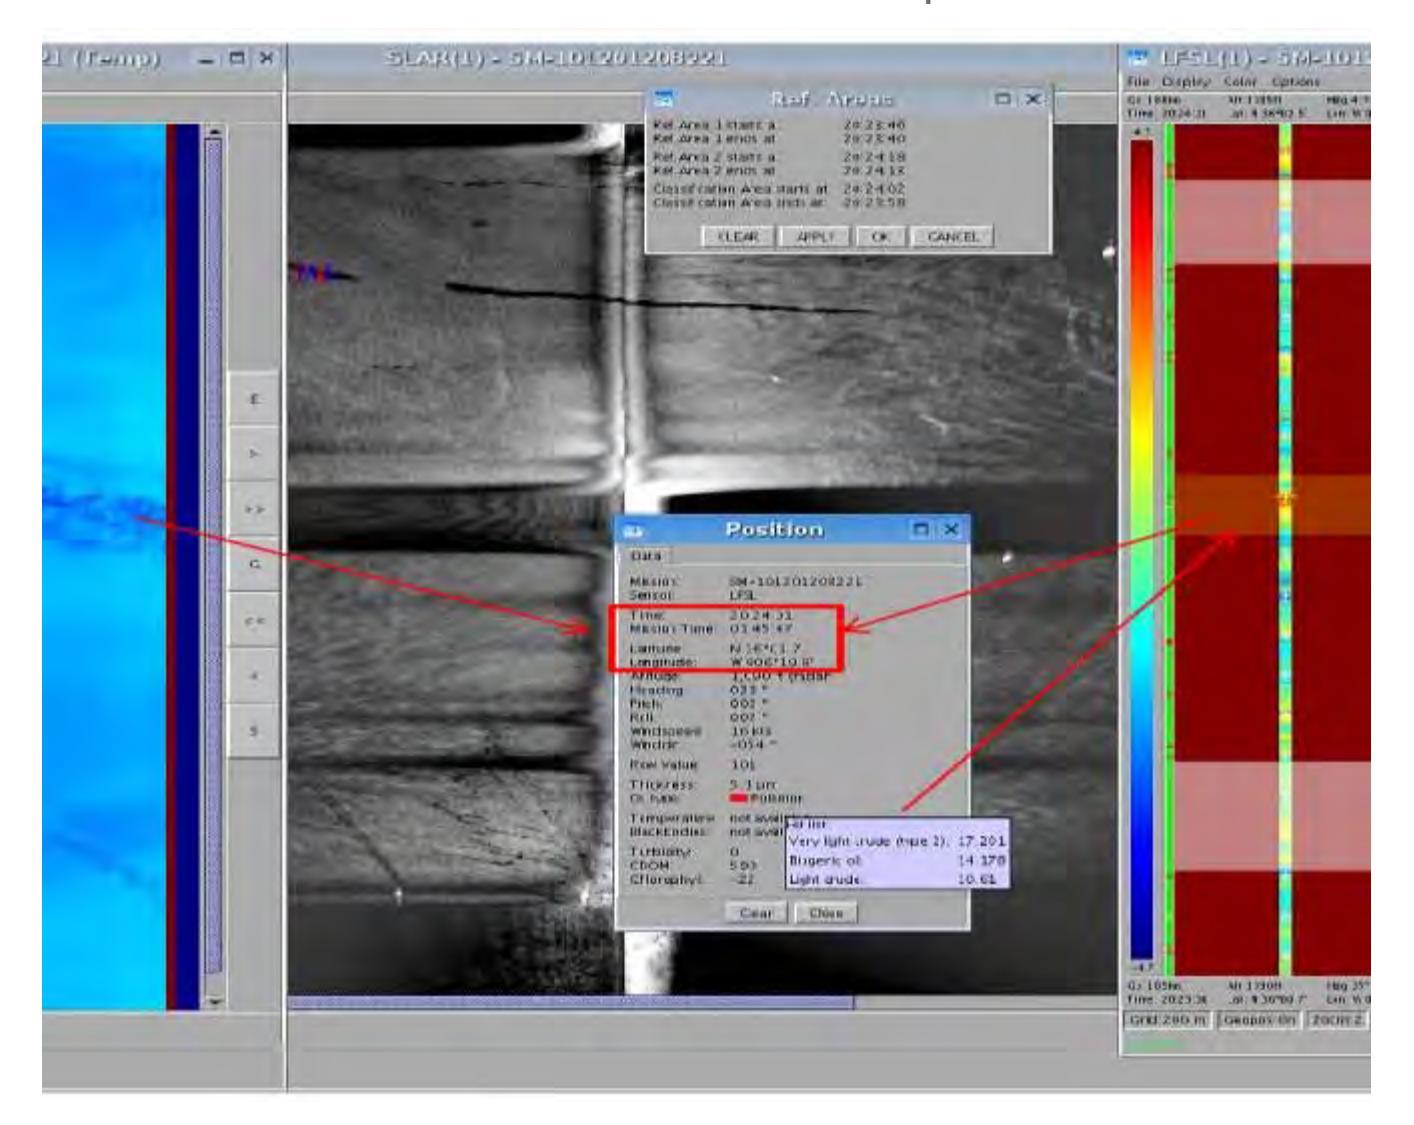
#### **B. SENSOR IR/MRW/LSF**

The LFS sensor classifies the slick as pollution

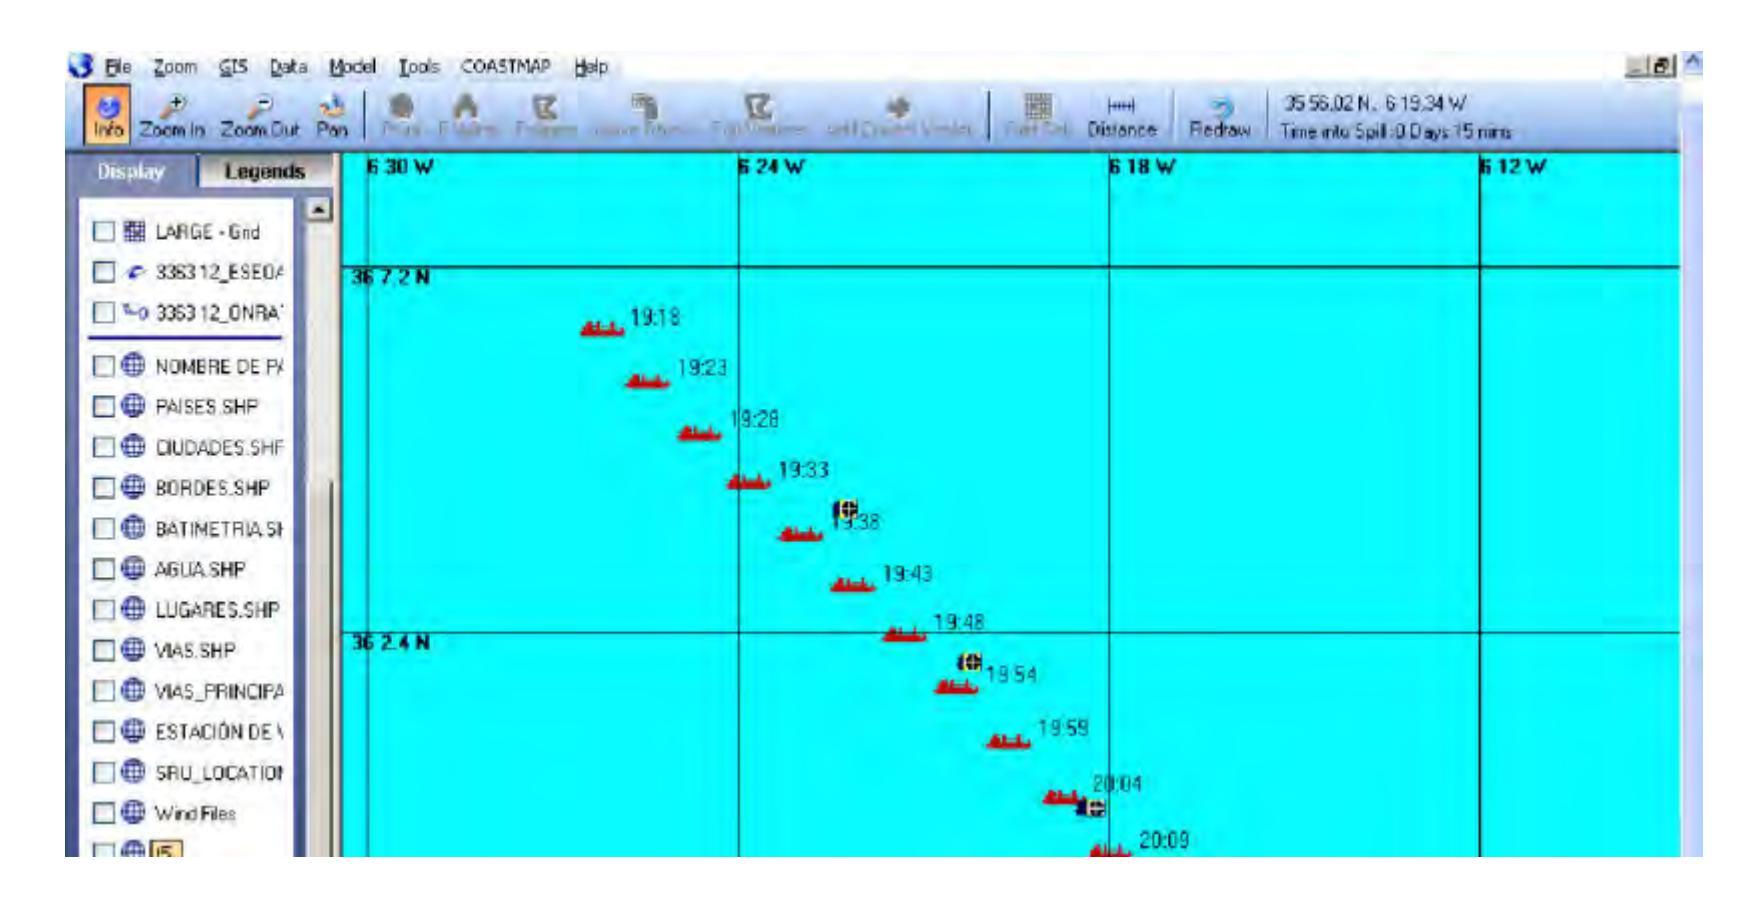
### Study Oilmap-AIS.

- 1 The operators from the aircraft Sasemar 101 confirm a discharge connected to the wake of the vessel VENAOIL XXI INO N= 3001071, the surrounding area being clean.
- <sup>2</sup> The vessel is identified by the aircraft Sasemar 101 by its AIS signal and the identity is confirmed by the further interrogation of the operators.
- 3 The discharge has been detected by the following sensors SLAR, IR, LSFL, that classifies as "Pollution" (see pages nums. 9 and 10)
- 4 The polluted area according to the SLAR sensor is of 1.54 km2. The slick position is bearing 248° from TRAFALGAR CAPE at 17,83 Nautical Miles.
- 5 The operators confirm that the discharge stops after the vessel was contacted by radio. The vessel denies the discharge when being interrogated by the operators.

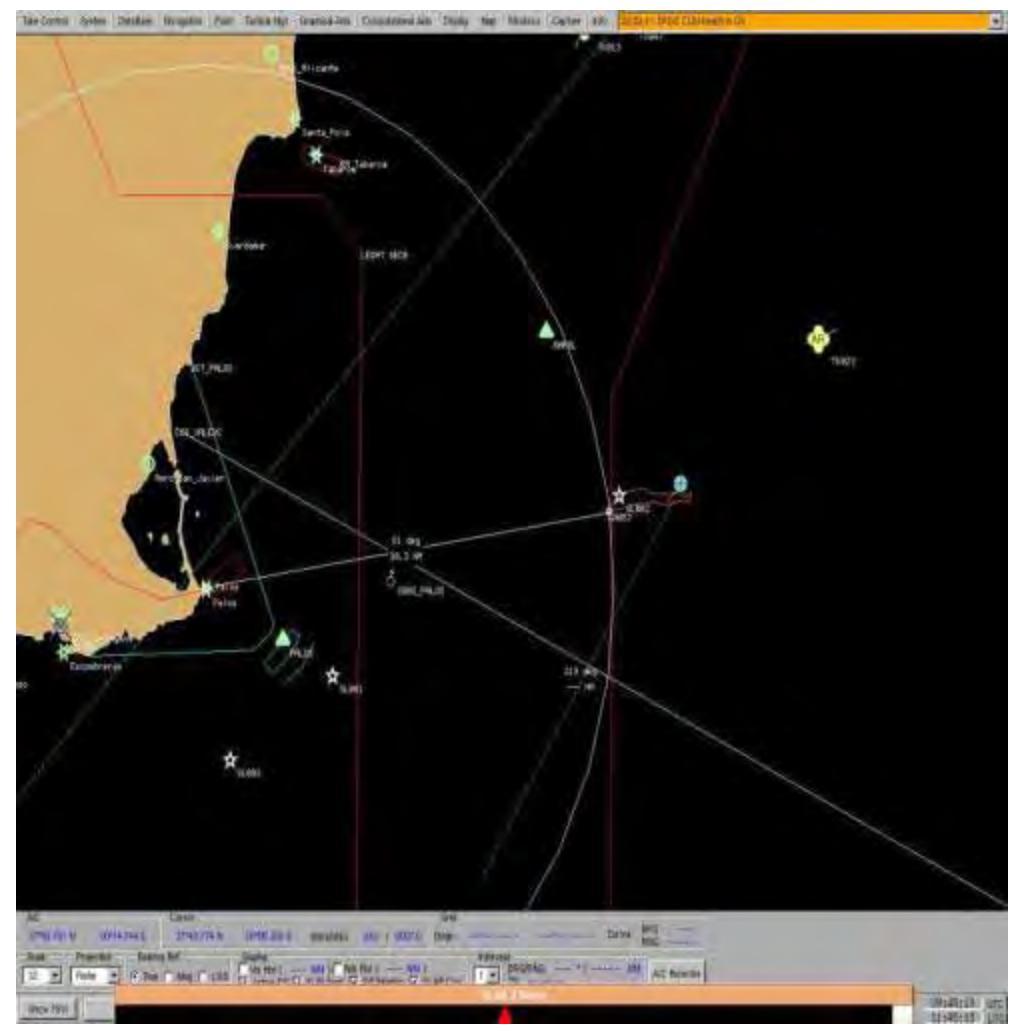
### 2. Slick position

The slick position is bearing 81° from Gata cape at 38,3 Nautical Miles, as shown in the following image.

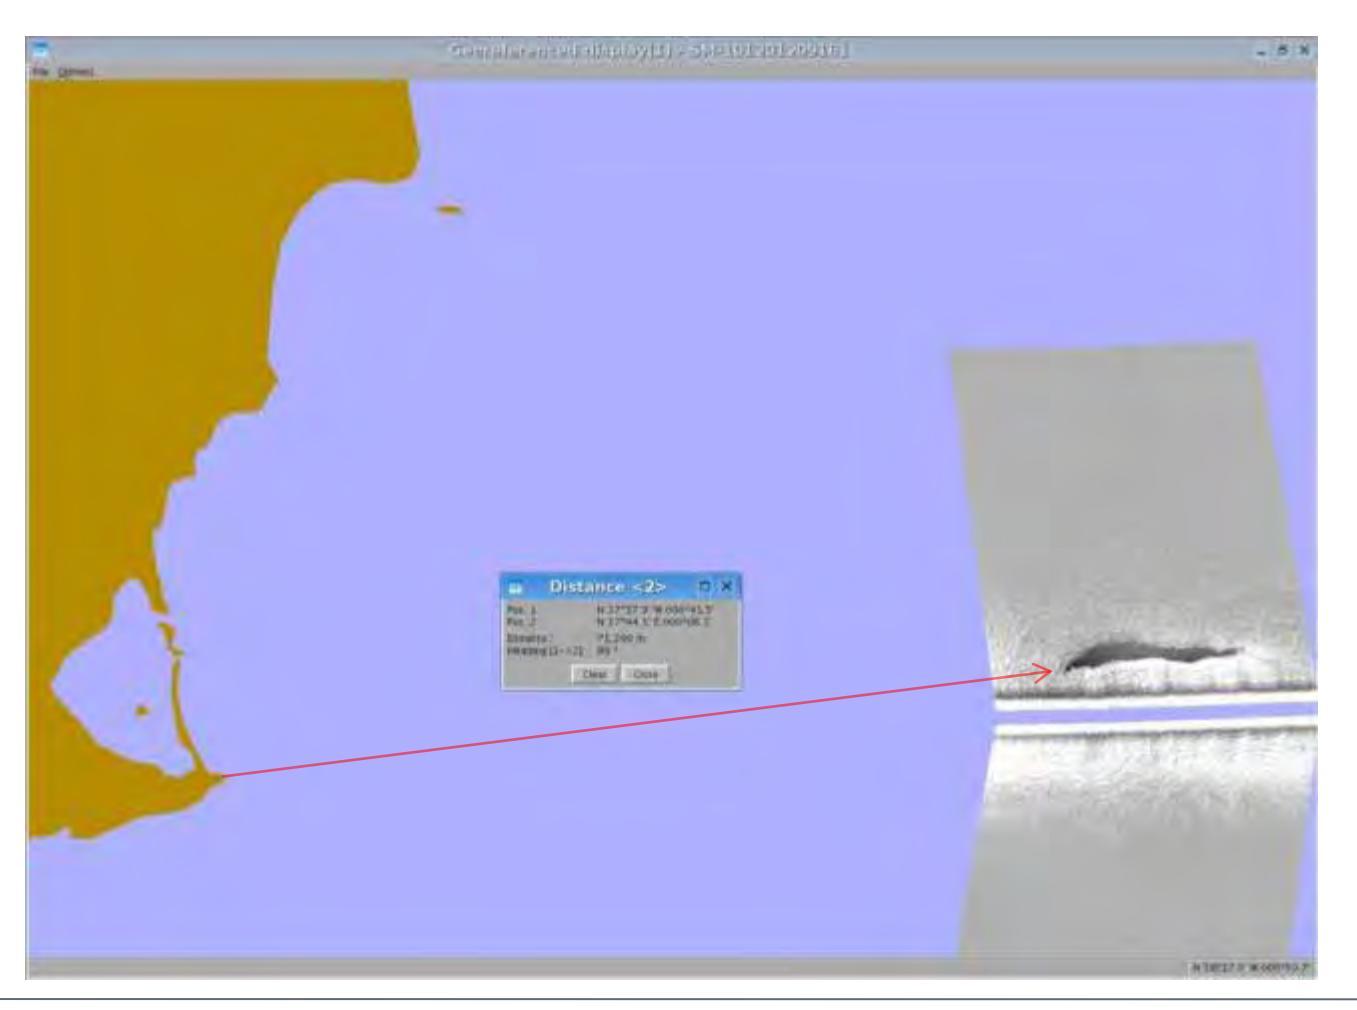
### 2. Slick position

The slick position is bearing 81° from Gata cape at 38,3 Nautical Miles, as shown in the following image.

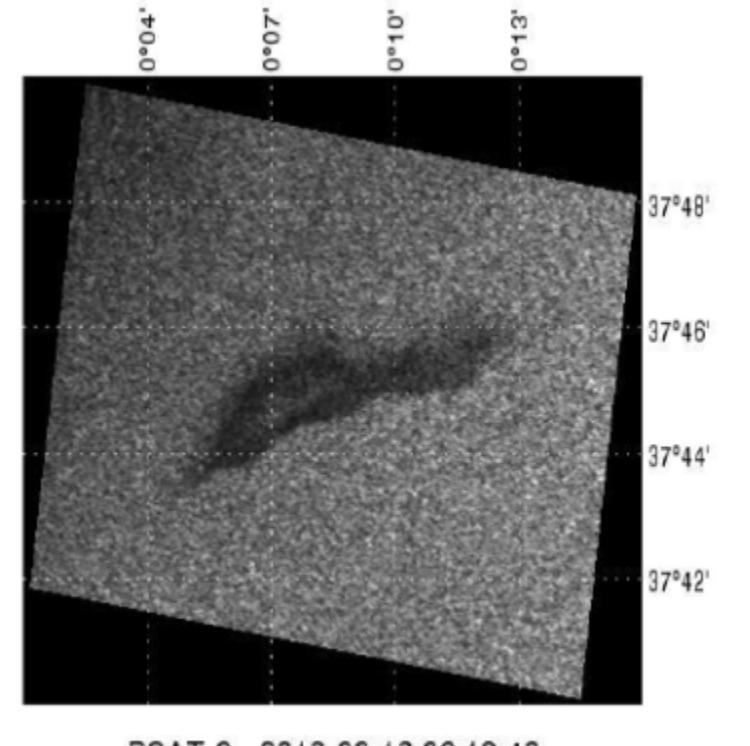
## 3. Satellite images

Satellite image showing the slick reported by CLEANSEANET.

Clea	nSeaNet Alert Report			SPA	Ac	quisition	2012-09-16 06:12:59 UTC		
E	MSA scene	ID 23944	RADARS	AT-2 - SAF	R 23944 5				List of Spills	GIB Viewer
		SAR Wind at Center		and the second	Length	Width		Alert	Number of	Oilspill
Centre	Position	SAR Wind	at Center	Area	Length	Width	Class	Alert	Number of	Oilspill
Centre	Position Longitude	SAR Wind Direction (Fram)	at Center Speed (m/s)	(km <sup>a</sup> )	Length (km)	Width (km)	Class (A/B)	Alert Level	Number of slicks	Oilspill Warning Issued

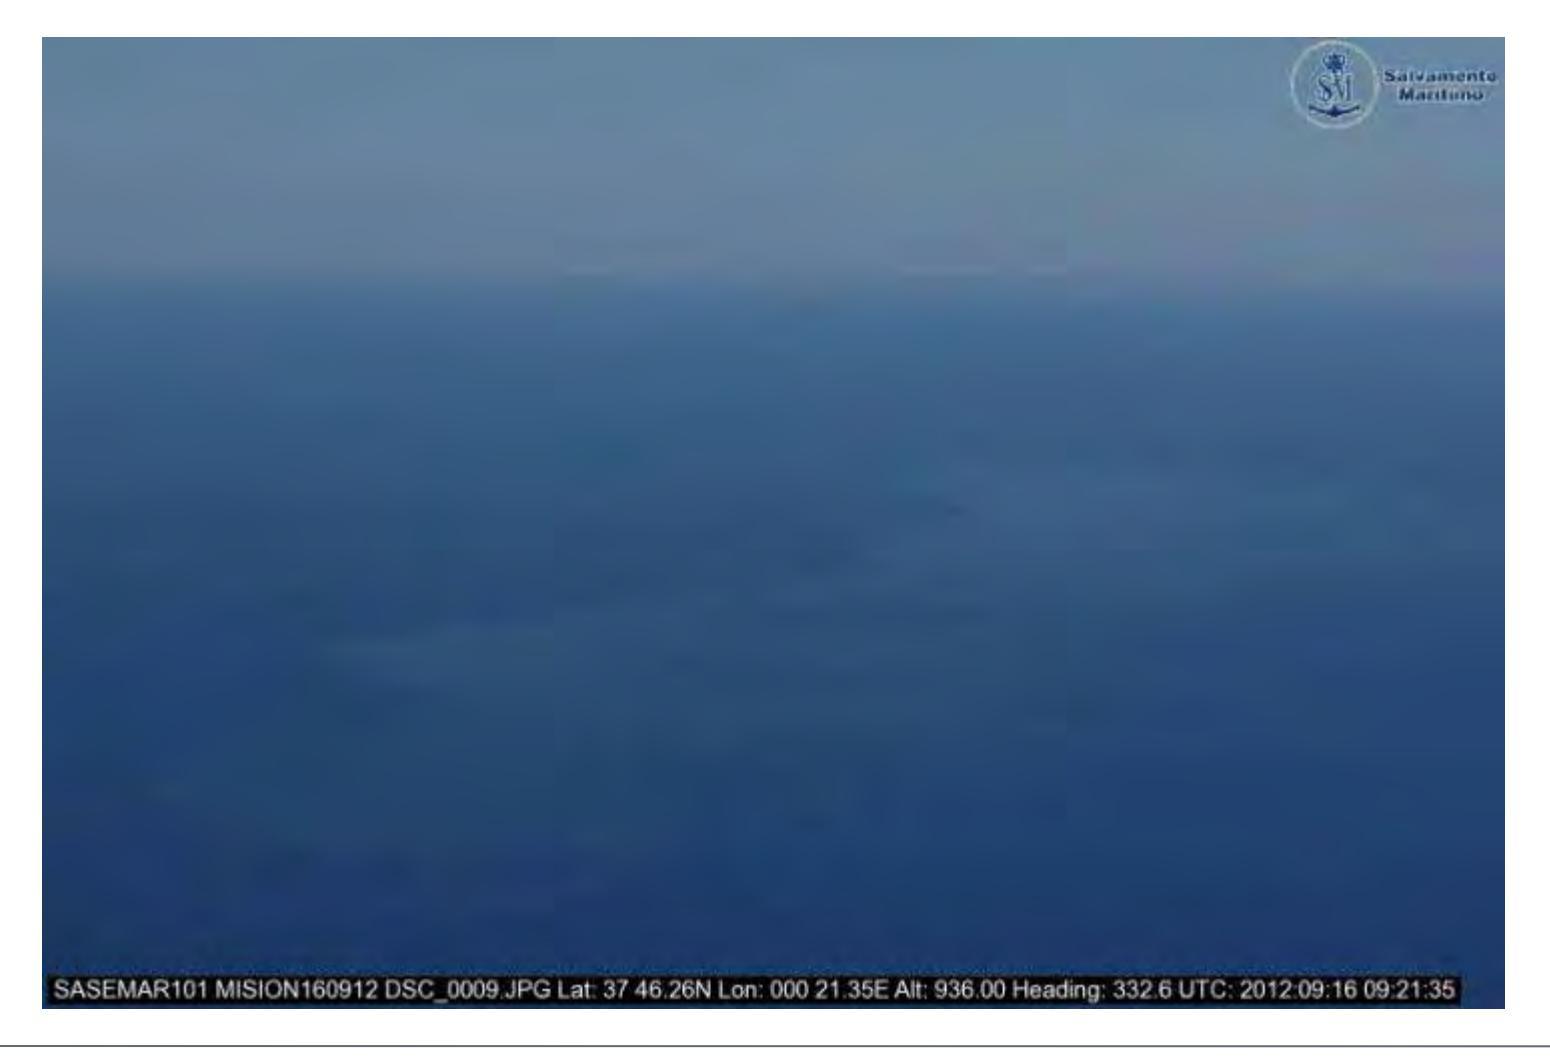
## 4. Photographs and FLIR images

Photograph of the slick.

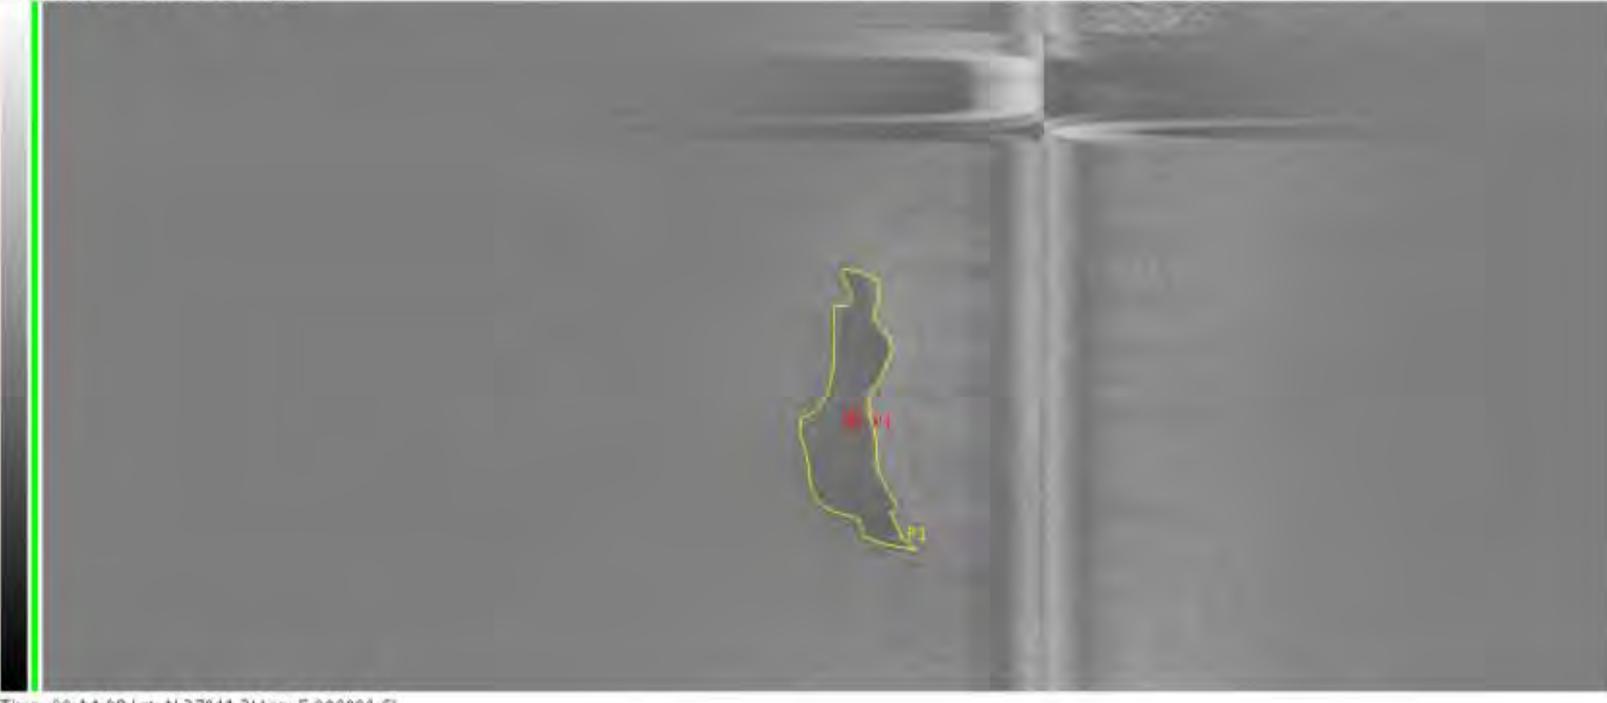
#### 5. SLAR

SLAR image which shows the length and direction of the slick, its central position and dimensions of the plotted polygon.

Sensor: SLAR (Grid: off, Geopos: on, Geotarget: off, Zoom: 1) LUT Range: 0 - 65535 Mission: SM-101201209161 2012-09-16 08:47:50.0 ACFT EC-KEK Op: PABLO BENJUMEDA Op2: ALBERTO VALLS Time: 09:20:42 Lat: N 37\*44.1' Lon: E 000°22.5' Gs 154knAlt --- Hdg 336' W/V 0\*/0kn

Time: 09:14:08 Lat: N 37°41.2' Lon: E 000°01.6" Gs 195knAlt 3061ft: Hdg 91° W/Y 95°/3kn

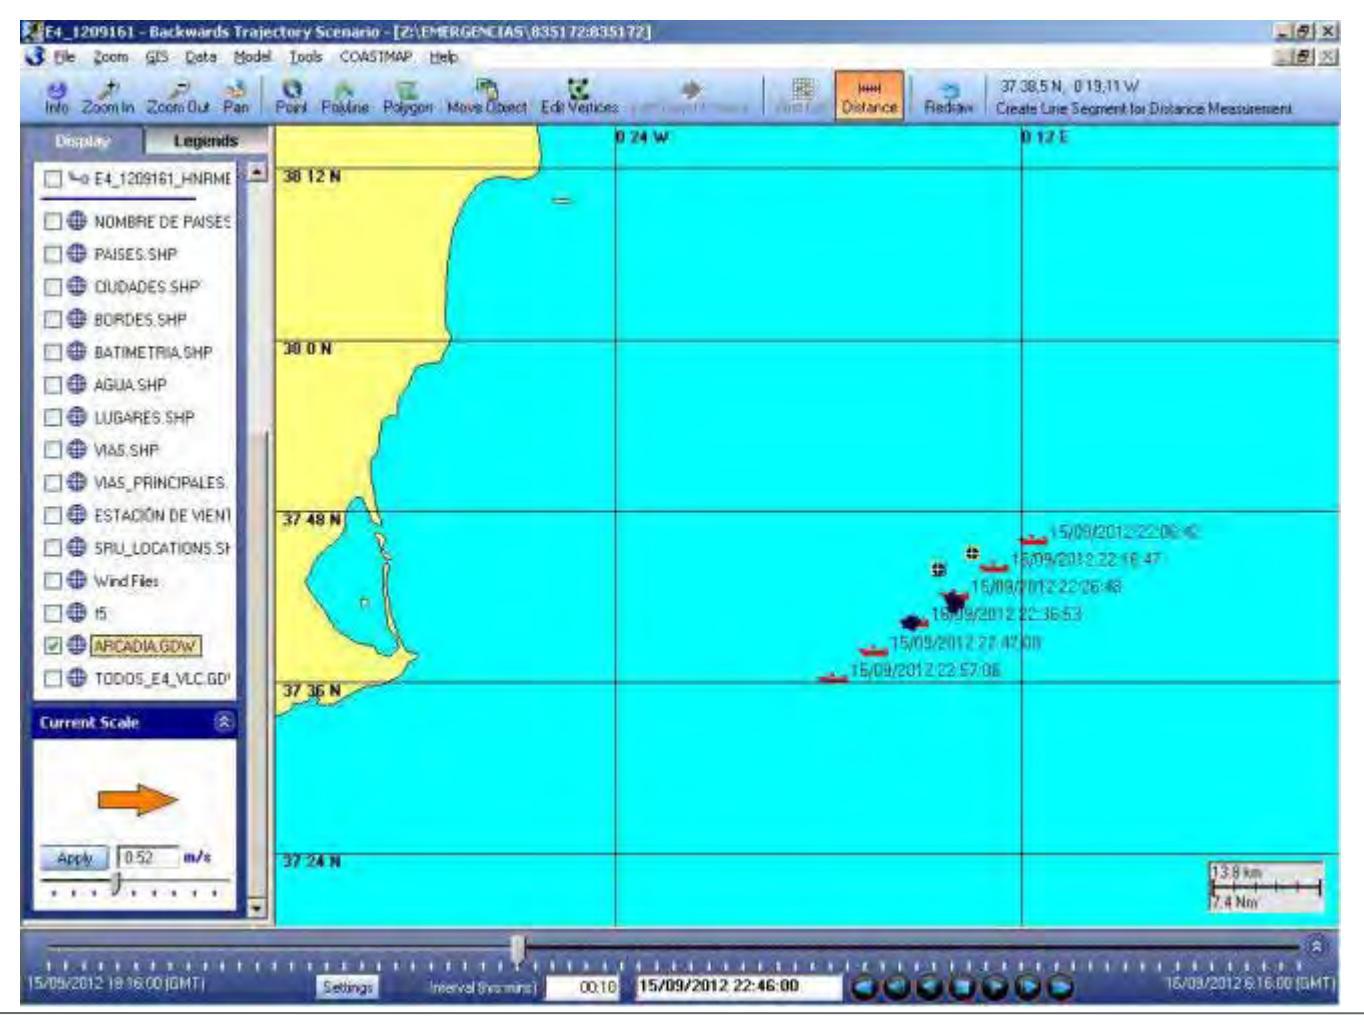
## 7. Backtracking analysis Oilmap-AIS.

The backtracking analysis of the slick using AIS data identifies the vessel, as the suspected vessel of the pollution and concludes the discharge started at 22:16 UTC and finished at 22:36 UTC.

- It was received at MRCC Valencia, CleanSeaNet Alert Report, nº 23944, acquisition time, may, 16<sup>th</sup>, 2012 at 06:12 hours UTC, where it is detected a possible oil slick named E4.
- 2. The operators from the aircraft A/S SASEMAR 101 confirm the detection of a slick on September, 16<sup>th</sup>, 2012 at 09:10 hours UTC.
- 3. According to the Bonn Agreement Oil Appearance Code, the pollution is classified as "SHEEN" by the trained operators. The photographs taken during the flight support this conclusion. Laser sensor classified the pollution as "Water/Biogenic"
- 4. The suspected vessel, is identified through the backtracking-AIS analysis.
- 5. The polluted area according to the satellite image is of 0,51 km<sup>2</sup>. The slick position is bearing 81° from Palos Cape at 38.3 NM.
